June 1, 2020

**Subject: High Point Estates (Adams Road Trust)
Construction Completeness Review**

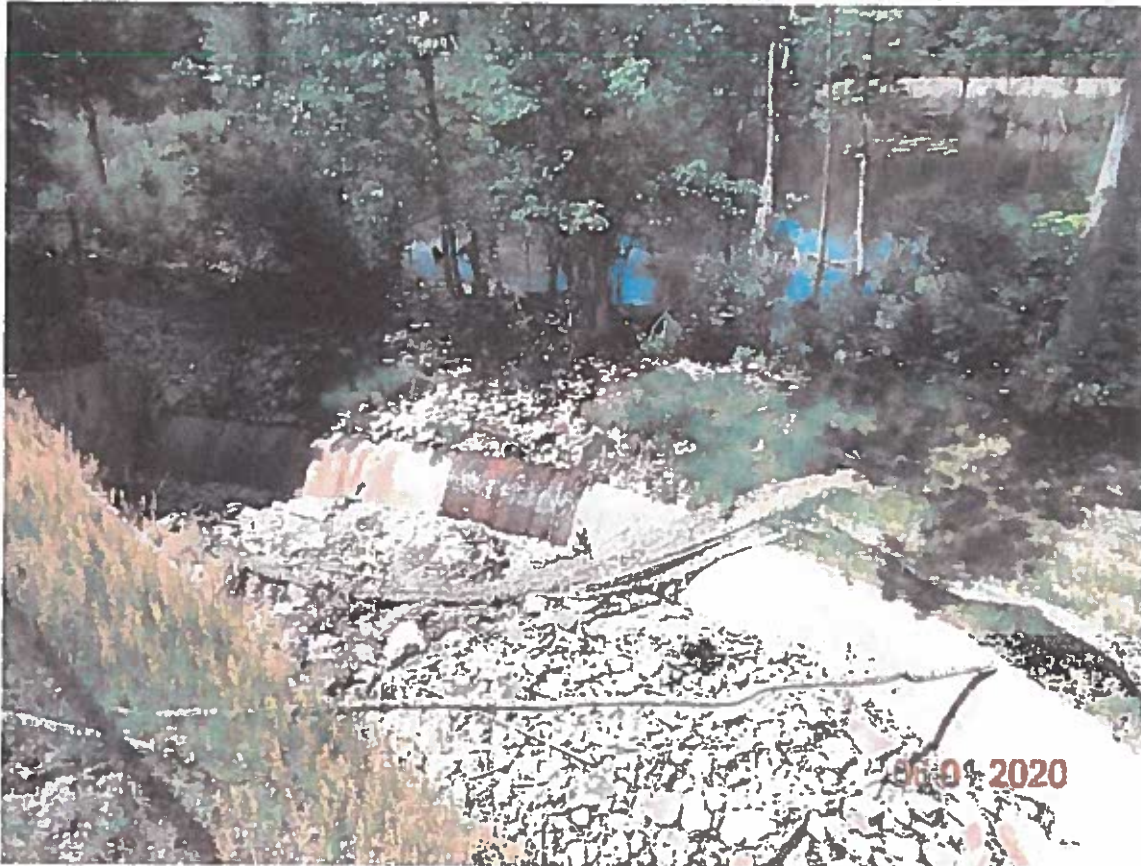
17. *Fill the settlement/depression in the ground at the top of the inlet weir at the triple culverts at High Point Drive station 3+60+/- left and stabilize the ground surface.*

The grass germinated. However, the pond had overflowed to the culverts and washed away some of the soil, leaving rock/riprap that appeared to be stable. On June 1, 2020, the area above the concrete weir appeared to be reasonably stabilized and the water level in the pond was still high (about ready to spill over toward the culverts). Earlier flow conditions had caused some of the turf matting to wash toward the inlet ends of the culvert. The loose turf matting needs to be removed. A photograph is presented below.

Area above the concrete weir at the inlet end of the triple culverts.
