INSPECTION REPORT LOT 76

Grafton, MA

LOCATION: High Point Estates
INSPECTION DATE: Feb 25 2019

REPORT DATE: Feb 26 2019
INSPECTOR: Patrick Garner

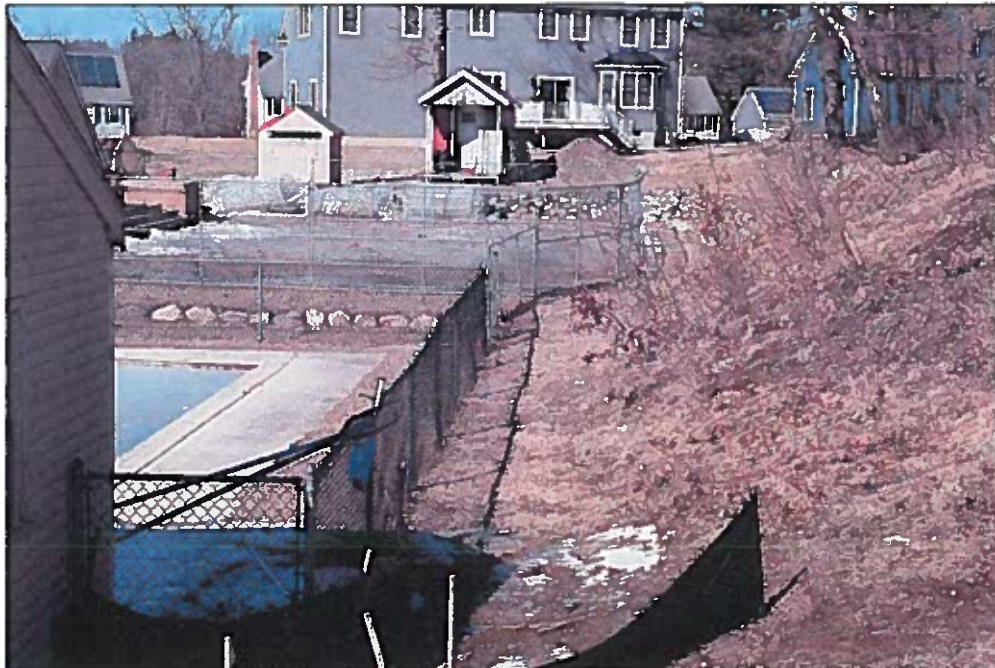
Fig. 1. Rear of Lot 76 (photo taken from Lot 55). Subdivision Open Space lies to the right of rightmost fencing. House shown in middle rear of photo is on Lot 73.

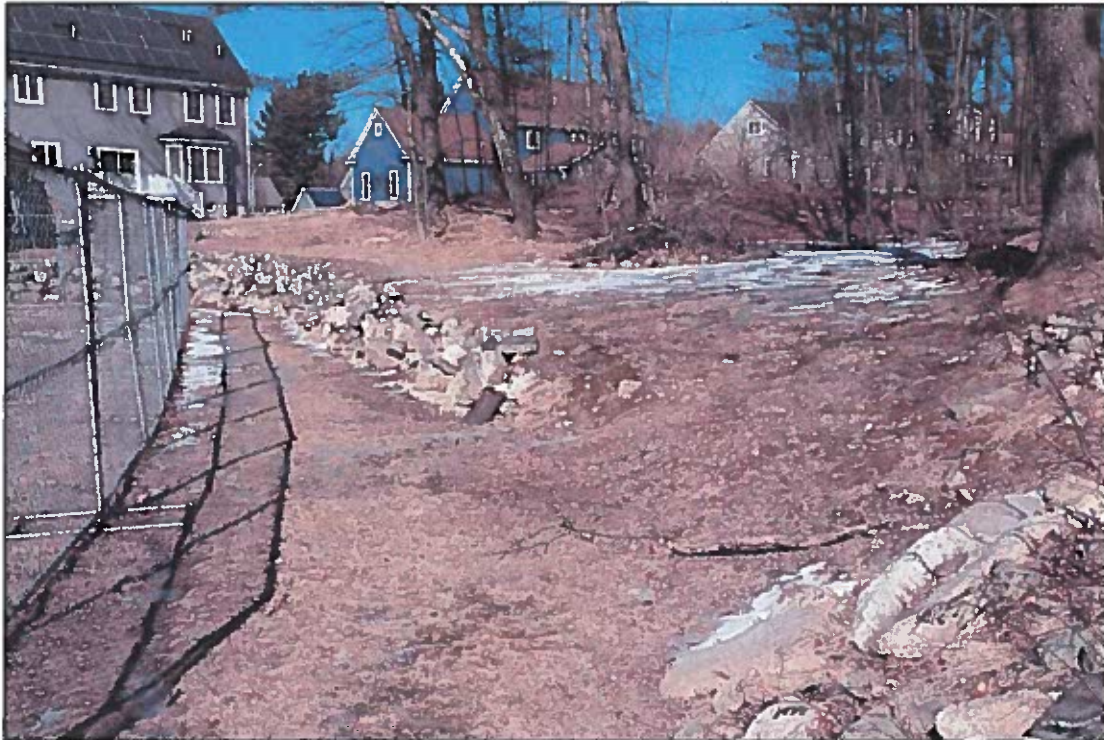
Fig. 2. Lot 76 property line runs down fence shown to left. Open Space lies directly to the right of fence. Note the new stonewall approx. 15-feet right of fence line, as well as cleared area beside fence and to the right. Depth of clearing into the protected Open Space is approx. 60-feet. Also note that grading by owners of Lot 76 slopes from inside the Open Space downward and toward pool area.

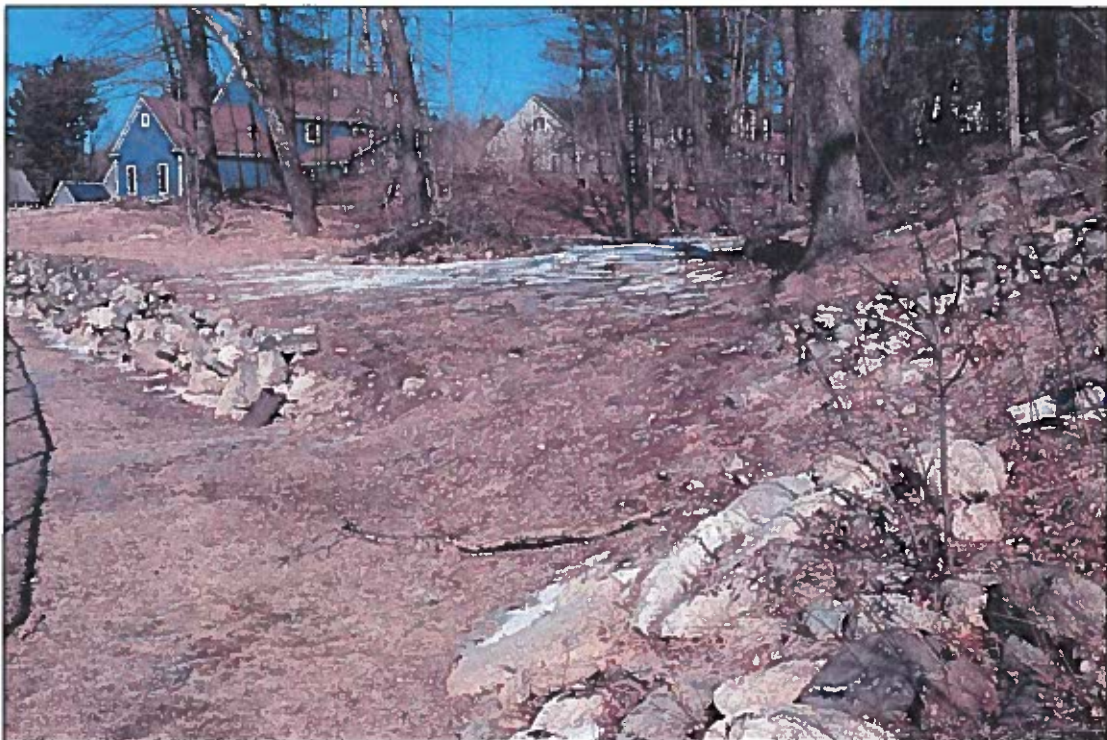
Fig. 3. Second view of Open Space clearing. All of the area with snow was cleared without permission. Note that topography slopes, without exception, right to left toward Lot 76.

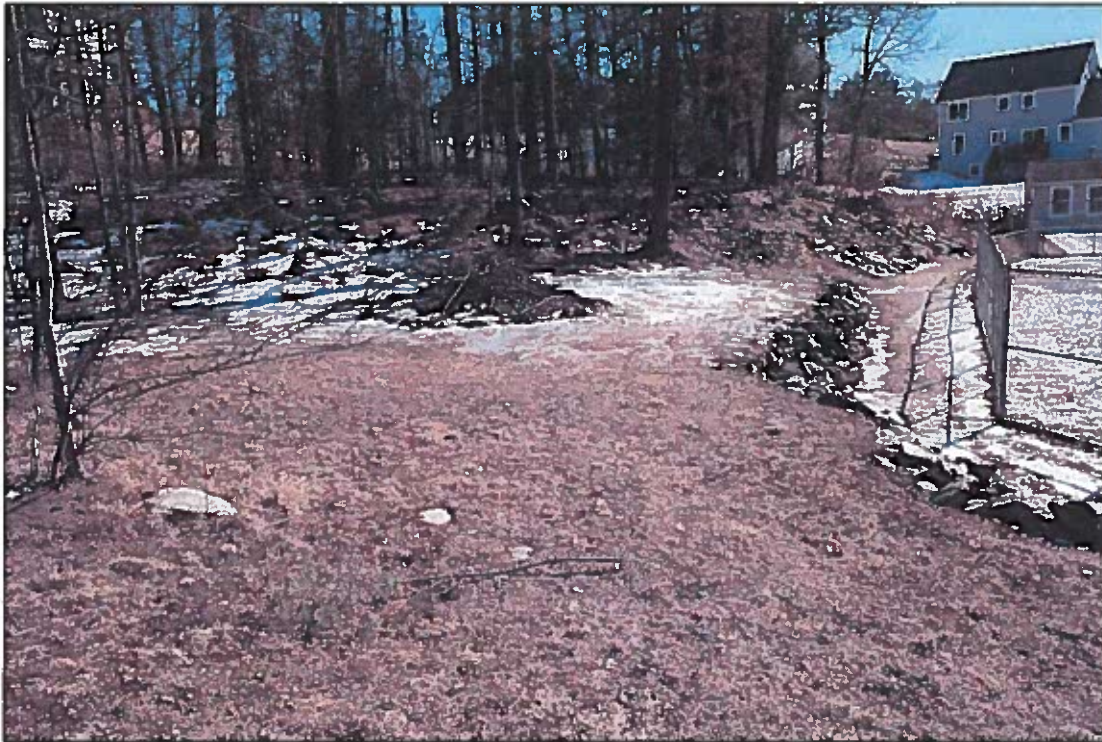
Fig. 4. Alternate view of cleared Open Space (photo taken from Lot 73). Lot 76 lies to right, Open Space to left. The area grassed and graded in left 3/4s of the photo was formerly vegetated; all trees and shrubs were removed and topography graded toward Lot 76 to right.

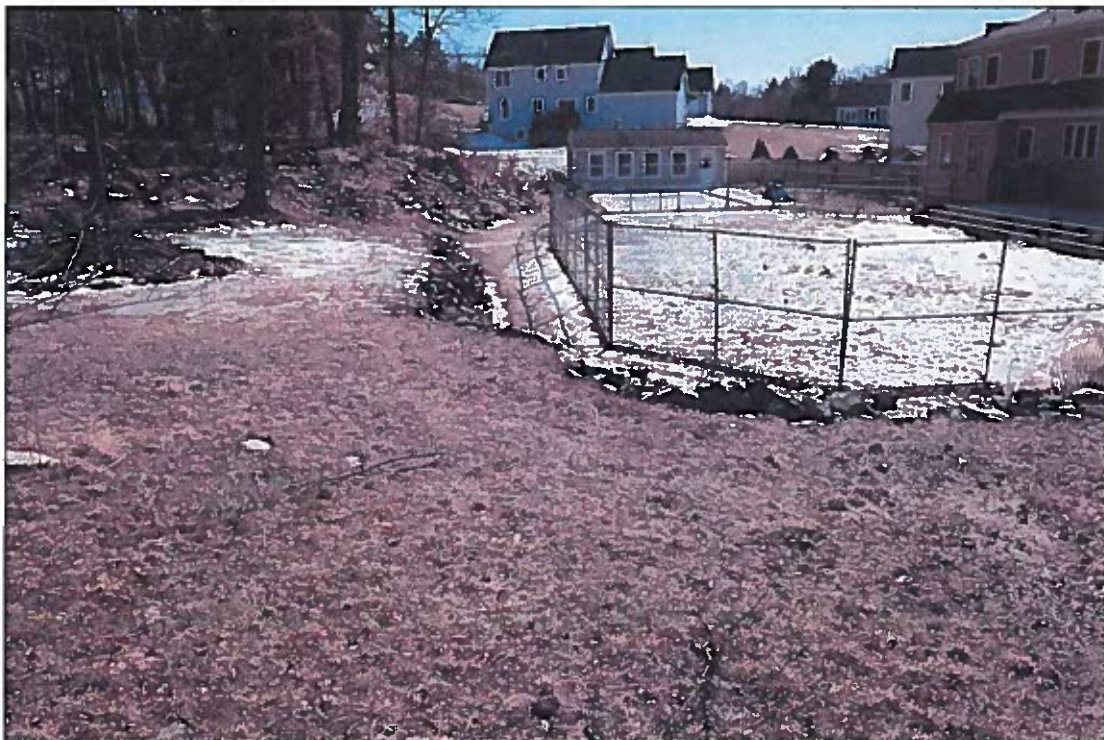
Fig. 5. Alternate photo of cleared Open Space. House on Lot 76 appears to right,
