# Site Visit Report

<b>Date:</b>	December 22, 2022	<b>Prepared By:</b>	Daniel Sheehan
<b>Client:</b>	Grafton Planning Board	<b>Arrived on site:</b>	3:30 PM
<b>Project:</b>	130 & 134 Worcester Road	<b>Left site:</b>	4:00 PM
<b>Contractor:</b>	Page Contracting, Inc.	<b>Site Conditions:</b>	Dry to dmap
<b>Contractor Contact:</b>	Dan Page	<b>Weather:</b>	35° Overcast to light rain

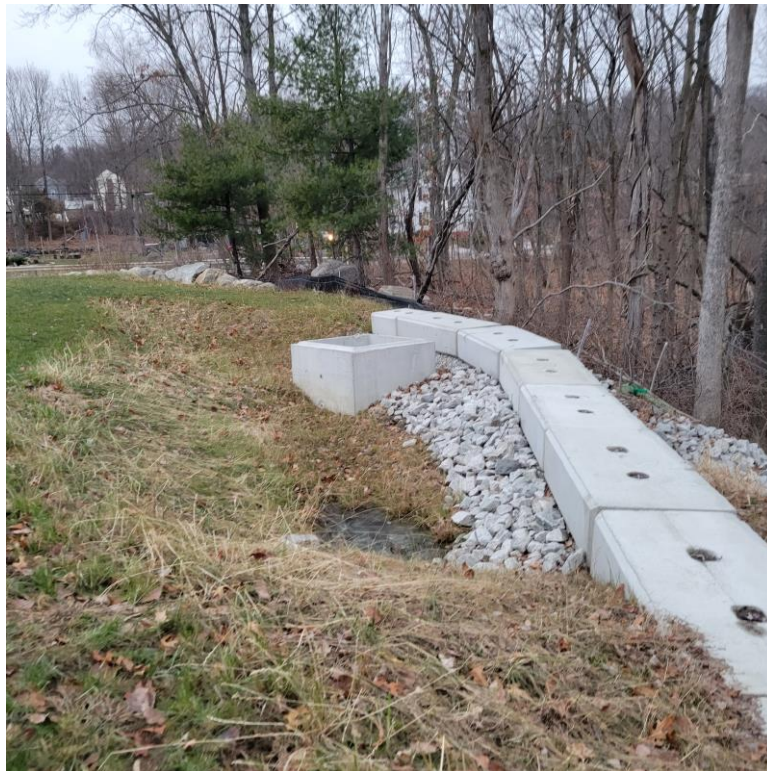
site encroaches into the basin bottom and may prevent the basin from having a 3H:1V slope on the northern side of the basin. Furthermore, on the northern side of the basin crushed stone was installed along the interior basin slope in lieu of vegetation. The crushed stone creates a hydraulic connection between the impounded stormwater within the basin and the retaining wall. Photo 1 is provided below to show the retaining wall encroaching into the basin area.

**Our comment remains and the contractor did confirm that the retaining wall was constructed closer to the stormwater impoundment than designed. The contractor also informed me that the design engineer believes that there is enough available area to reconstruct the stormwater basin to comply with the stormwater standards. GEI would like to reiterate that there is still a hydraulic connection between impounded stormwater within the basin and the retaining wall. This hydraulic connection will need to be addressed and eliminated by the design engineer's team during the stormwater basin's redesign.**

**As stated above, the contractor informed me that the northern retaining wall was relocated closer to the stormwater basin to prevent the need of installing a ±16-foot tall retaining wall. Please refer to "Stormwater Basin" section above outlining the concern for a hydraulic connection.**

**Photo 1:** Retaining wall encroaching into basin bottom and the outlet control structure (OCS-101).

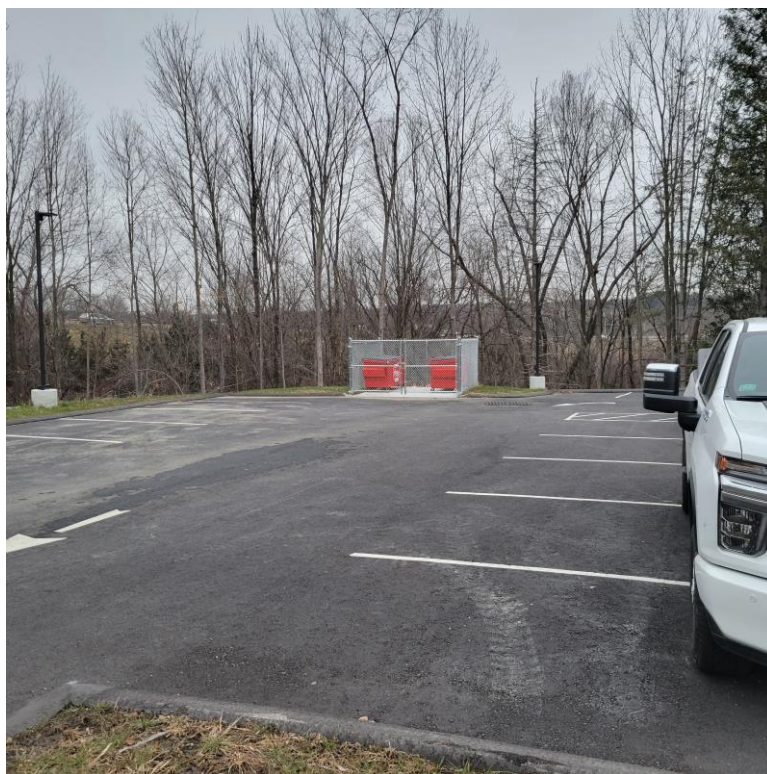
- *Dumpster Pad: Dumpster Enclosure – "to-be completed".*
  - *The six-foot fence board screening needs to be installed.*  
**A chain link fence has been provided at the dumpster enclosure. The contractor informed me that the fencing is required to be transparent by the CCC.**

**Photo 2:** Dumpster enclosure with fencing installed.

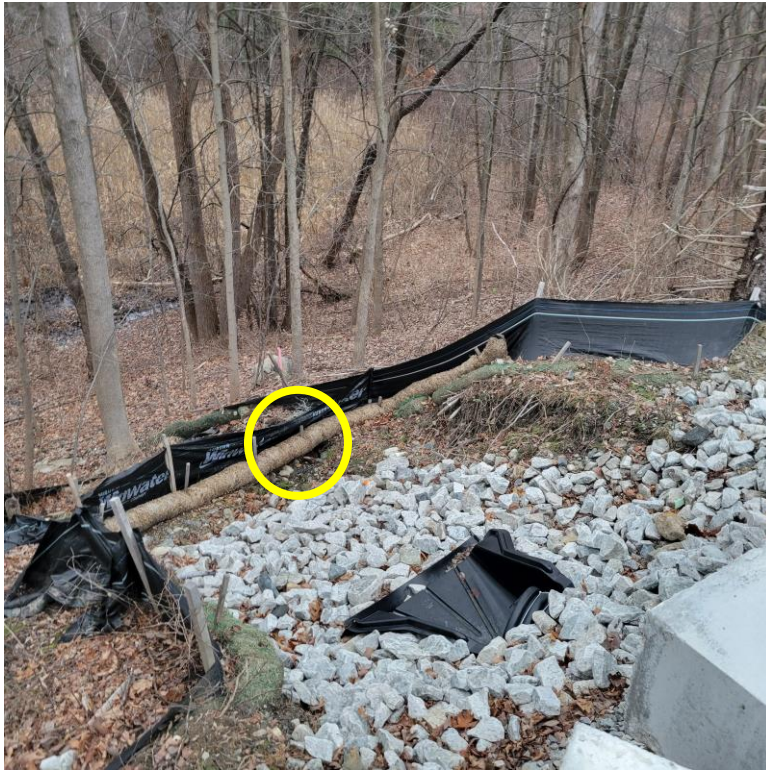
- **Flared End Sections: FES-01 and FES-02 – “to-be completed”.**
  - *FES-01 has not been installed yet. Both riprap aprons at the flared end section outfalls need some improvements. More specifically, FES-02's outfall is currently filled with sediment and needs to have the sediment removed and FES-01's outfall needs to be expanded to the northeast to the full apron length.*  
**FES-01 has been installed. However, it does appear that the riprap apron for FES-01's outfall needs to be expanded to the northeast to the full apron length. Both outfalls had the previously observed sediment removed.**

**The perimeter controls are still in disarray and need to be reset/reestablished, however no additional sedimentation was observed. During our visit, the contractor informed me that they are hesitant to perform additional earth disturbing activities on the slope with the current frost-conditions. GEI understands the concern, however, believes less disruptive measures could be completed at FES-01 (e.g. extending riprap apron, providing additional straw wattles, etc.).**

**Photo 3:** FES-01 installed with a refreshed riprap apron. Note: perimeter controls appear to be undermined in the encircled area.

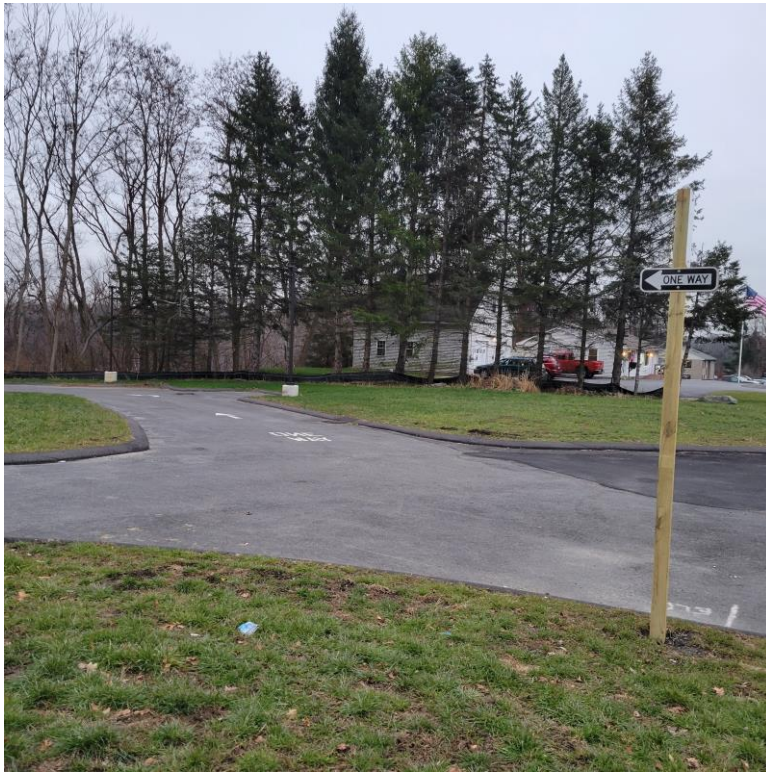
**Photo 4:** General condition of driveway entrance with pavement markings and temporary signage.
