SECTION THREE

EXISTING CONDITIONS

**NEW GRAFTON HIGH SCHOOL
SCHEMATIC DESIGN REPORT**

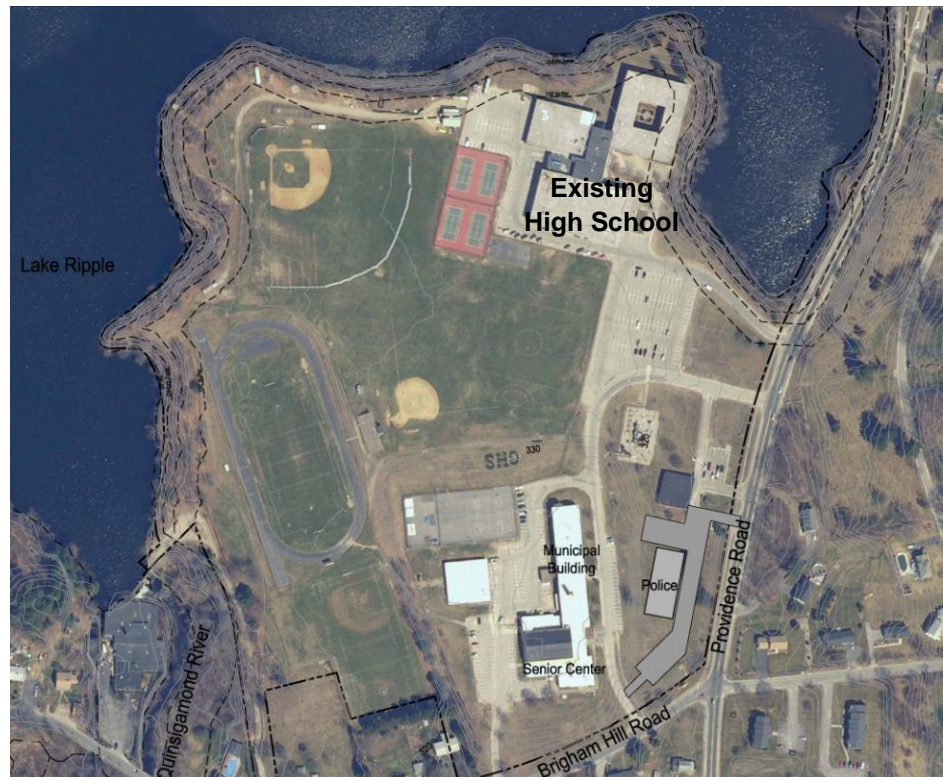
Figure 3.A: Existing High School Site

The 46-acre site is primarily occupied by the existing high school and accompanying ball fields and parking. The southeast corner of the site is

occupied by the new Grafton Police Department, the Municipal Building, the old and unoccupied police department building, and the School Department Building. The site is predominately flat with steep slopes down to Lake Ripple along the north and west sides of the site. The Municipal and School Department buildings are on a ten-foot rise. The east and south sides of the site are bounded by Providence Road and Brigham Hill Road, respectively.
