SECTION THREE

EXISTING CONDITIONS

3.1 GRAFTON HIGH SCHOOL EXISTING CONDITIONS

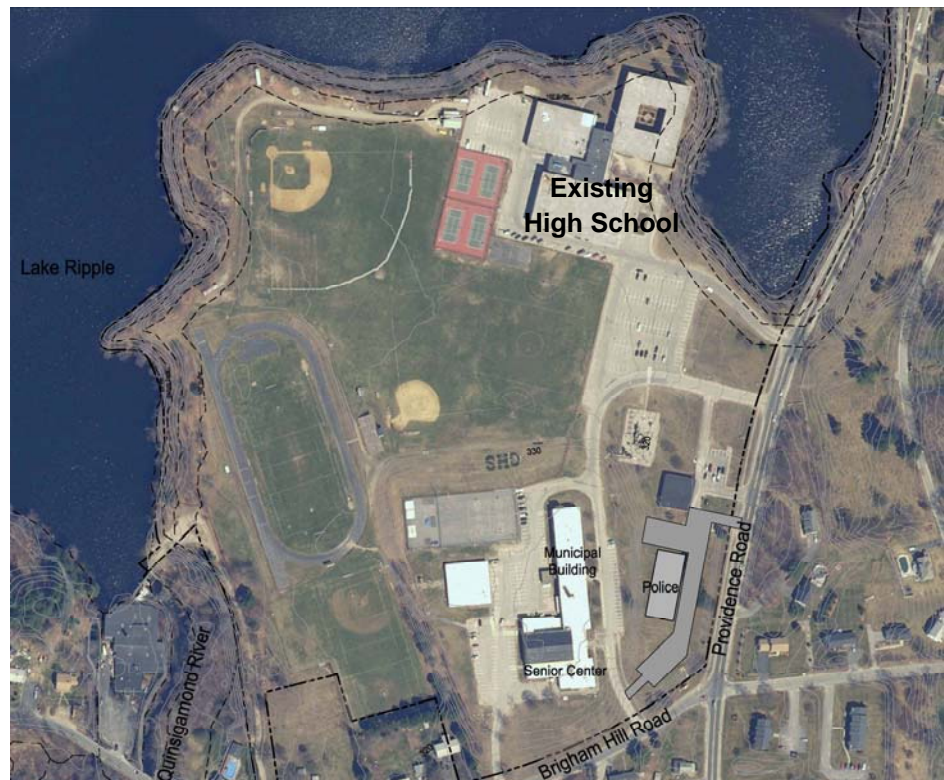
Figure 3.A: Existing High School Site

The 46-acre High School site is primarily occupied by the school and accompanying ball fields and parking. The southeast corner of the site is occupied by the new Grafton Police Department, the Municipal Building, the

old and unoccupied police department building, and the School Department Building. The site is predominately flat with steep slopes down to Lake Ripple along the north and west sides of the site. The Municipal and School Department buildings are on a ten-foot rise. The east and south sides of the site are bounded by Providence Road and Brigham Hill Road, respectively.
