BLACKBURN BUILDING CONSERVATION LLC

30 August 2018

During the month of June, Blackburn Building Conservation LLC performed restoration treatments on the sandstone and concrete columns at the Grafton Public Library. Due to weather conditions and poor repairs, the column bases were cracked and in poor condition.

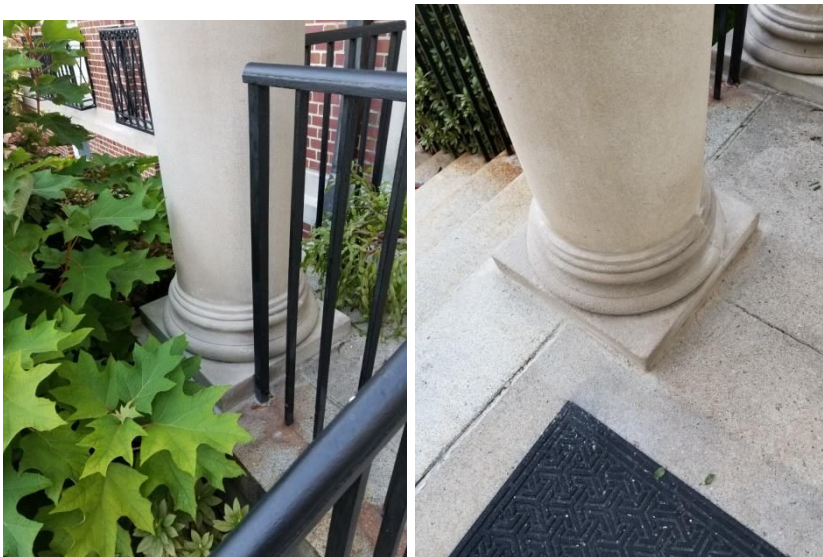
Lastly the columns were coated with a breathable clear coating to offer protection from environmental conditions. Columns after Restoration

******Based on our observations, it would be advisable to install bird netting at the top of each of the capitals to protect the bases from staining due to bird guano.**
